RESEARCH MEMORANDUM

AN EVALUATION OF ELECTROPOLISHED AND NONELECTROPOLISHED

BLADES OF ALLOYS REFRACTALOY 26, M-252, AND

WASPALOY IN A 133-9 TURBOJET ENGINE

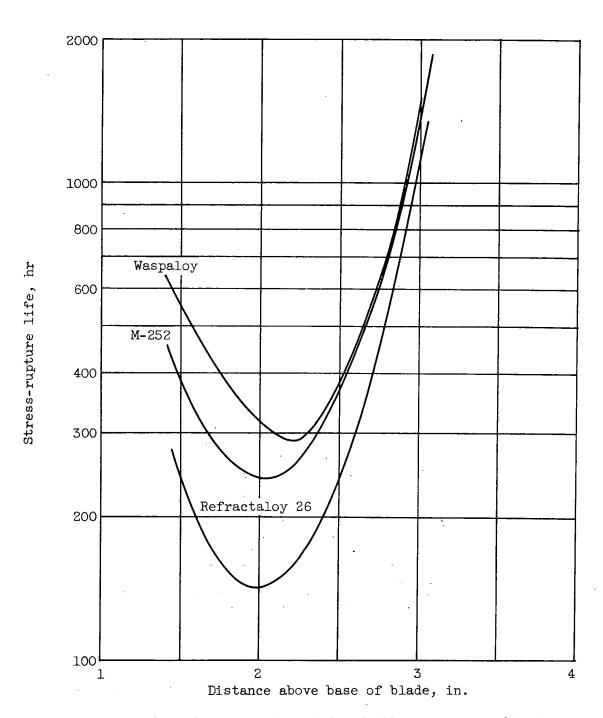
Figure 2. - Stress-rupture life of alloys corresponding to conditions of centrifugal stress and temperature of blades.

The results of the determination of the zone of minimum stressrupture life by the method previously described are shown in figure 2. The minimum of each curve represents the expected life and location of blade failure, if the failures were a result of the centrifugal stress and the temperature. The location and time to failure would be as follows:

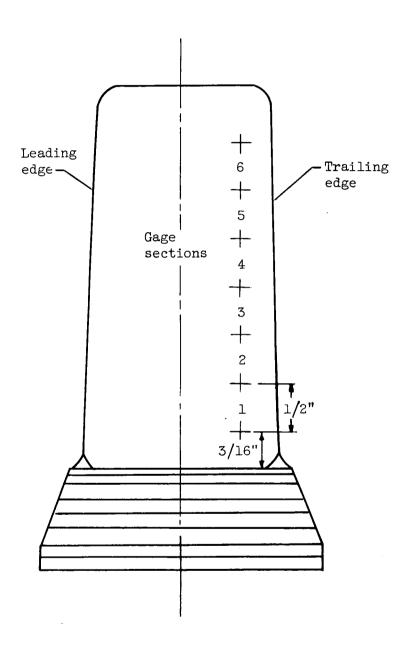
Figure 3. - Location of scribe marks on blades for elongation measurements (ref. 5).

From one to three blades of each group were scribed near the trailing edge at 1/2-inch intervals, as shown in figure 3 and described in reference 5. Blade elongation measurements were made at frequent intervals (after blade failures or necessary shutdowns) using an optical extensometer. Elongation data were influenced by the warpage and distortion of the blades. The chronological increase of elongation for each gage section was not obtained for alloys Refractaloy 26 and Waspaloy because the variations caused by the warpage and distortion were large enough to obscure the small elongations obtained for these alloys. The maximum elongation obtained for any section was plotted. The elongation of individual gage sections was obtained and plotted against the time of operation for alloys M-252 and S-816.

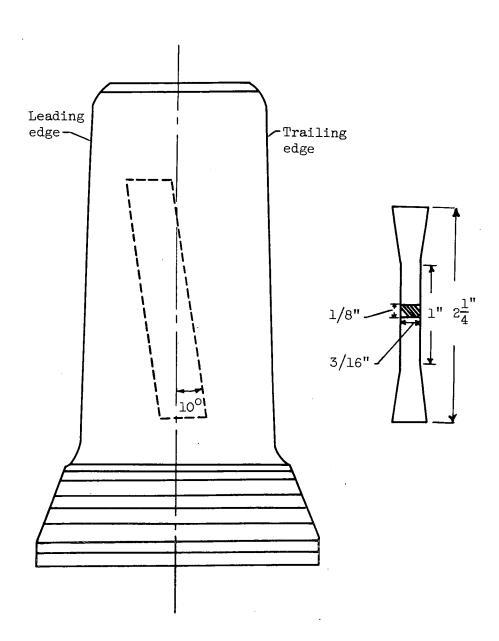
Figure 4. - Blade stress-rupture specimen and zone from which it was machined.

The stress-rupture properties of each alloy at various stress levels and 1500° F were determined from specimens cut from bar stock and from blade airfoils. The specimen cut from blade airfoils and the zone from which it was machined are shown in figure 4. The stress-rupture results were obtained to correlate the engine performance of blades with bar stock and blade airfoil specimen properties.

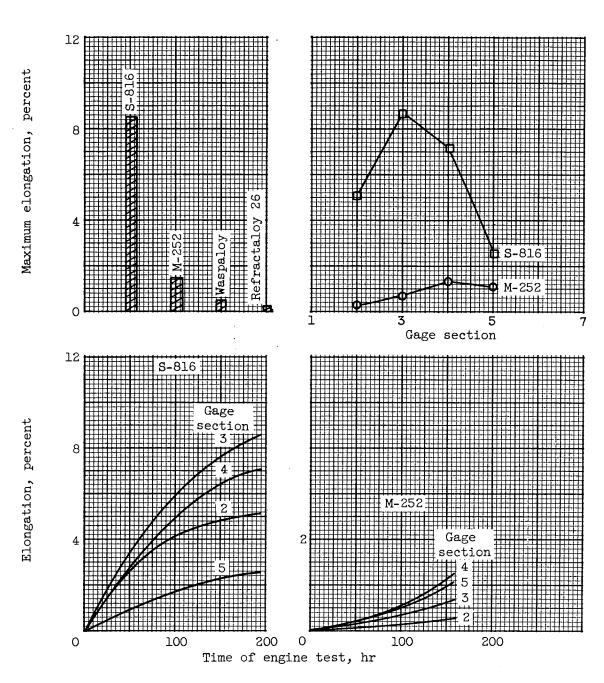
Figure 6. - Elongation of scribed blades in engine test.

Elongation of blades during engine operation. - The results of elongation measurements from scribed blades are shown in figure 6. The scatter of data on measuring elongation of Refractaloy 26 and Waspaloy prevented a determination of the elongation for the individual sections of the blade. The maximum elongation of the blades was determined and found to be small, with Refractaloy 26 elongating less than 0.2 percent and Waspaloy less than 0.5 percent. The data permitted a determination of the elongation of the individual sections of the scribed blades of M-252 and S-816. The maximum elongation of M-252 was 1.3 percent, while S-816 had a maximum of 8.7 percent. The maximum elongation occurred just above the center of the M-252 blades, while the S-816 blades elongated most just below the center of the blade.

Elongation or creep of Refractaloy 26, M-252, and Waspaloy, as with most nickel-base alloys, was small compared with S-816. Maximum alongations were 0.2 percent for Refractaloy 26, 0.5 percent for Waspaloy, and 1.3 percent for M-252, while S-816 elongated 8.7 percent (see fig. 6). The lack of ductility usually associated with low creep rates did not preclude good blade performance, for the blades were able to withstand the impact of fragments of failed blades as well as S-816 in this investigation.

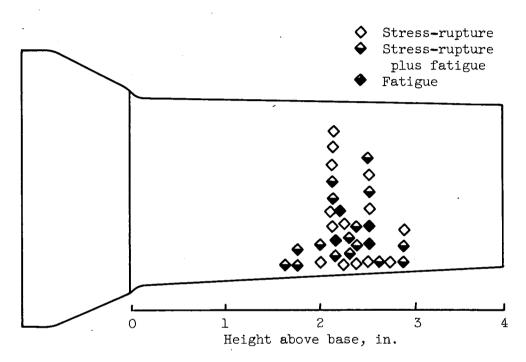
Figure 7. - Distance of failure above base for alloys Refractaloy 26, M-252, and Waspaloy.

Macroexamination of failed blades. - The distance of the failure above the base of the blade for the three alloys is shown in table II and figure 7, in which the damage failures are omitted. Seventy-five percent of all blade failures occurred in the zone from 2 to $2\frac{1}{2}$ inches above the base, which is about the zone of minimum stress-rupture life of the blades. The failures above and below this group were divided, with 15 percent occurring from $2\frac{1}{2}$ to $2\frac{7}{8}$ inches above the base and 10 percent from $1\frac{5}{8}$ to 2 inches above the base. The failure mechanisms, excluding failure by damage, were as follows: Stress rupture, 38 percent; stress rupture plus fatigue, 53 percent; and fatigue, 9 percent.

Seventy-five percent of the failures occurred about the zone of minimum stress-rupture life, as was previously noted.

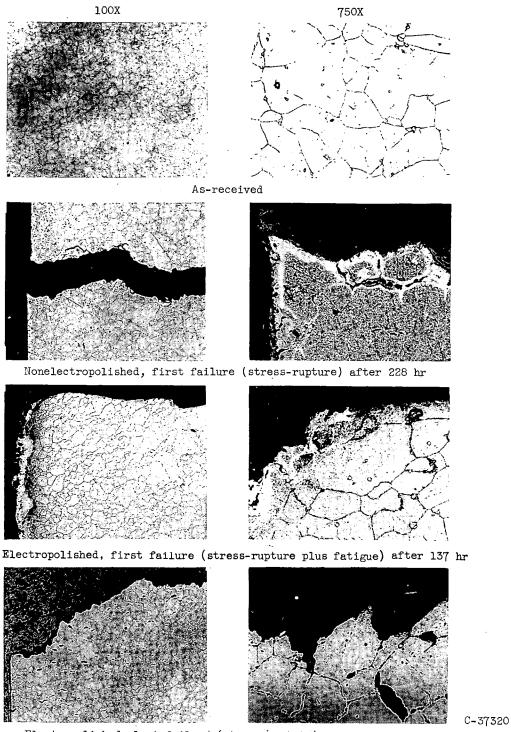
Figure 8. - Continued. Microstructures of as-received and failed blades.

failed blades showed an increase in the amount of fine, evenly distributed precipitates in the matrix. An oxide layer and depletion zone developed on the outside surface and fracture edge of some failed blades as a result of engine operation.

Electropolished, last failure (stress-rupture) after 324 hr (b) Waspaloy.

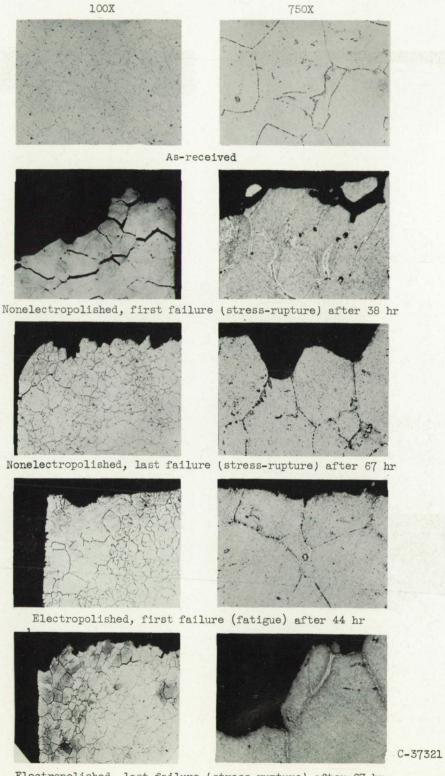
Figure 8. - Concluded. Microstructures of as-received and failed blades.

Microstructure. - The microstructures of as-received and failed blades of each alloy are shown in figure 8. The general microstructure of the alloys was changed somewhat by engine operation. There was, in the failed Refractaloy 26 blades, some evidence of additional fine, evenly dispersed precipitation in the matrix and some additional spheroidization of the grain boundaries. Also, a depletion zone developed around some grain boundaries. Normal aging such as this is expected in engine operation of a precipitation-hardened alloy. In the M-252 blades, the large residual precipitates were unchanged by engine operation, but there was some additional precipitation in Widmanstatten form. There was, as would be expected, no difference in the microstructure of electropolished and nonelectropolished blades of this or the other alloys. The Waspaloy

Electropolished, last failure (stress-rupture) after 67 hr (c) Refractaloy 26.
